VALVES AND VALVE PROBLEMS

MR. A. PERKINS (MSFC)

FACILITY FORM 602
N 67-19032
(ACCESSION NUMBER)
39
(PAGES)
TM-X-59419
(NASA CR OR TMX OR AD NUMBER)

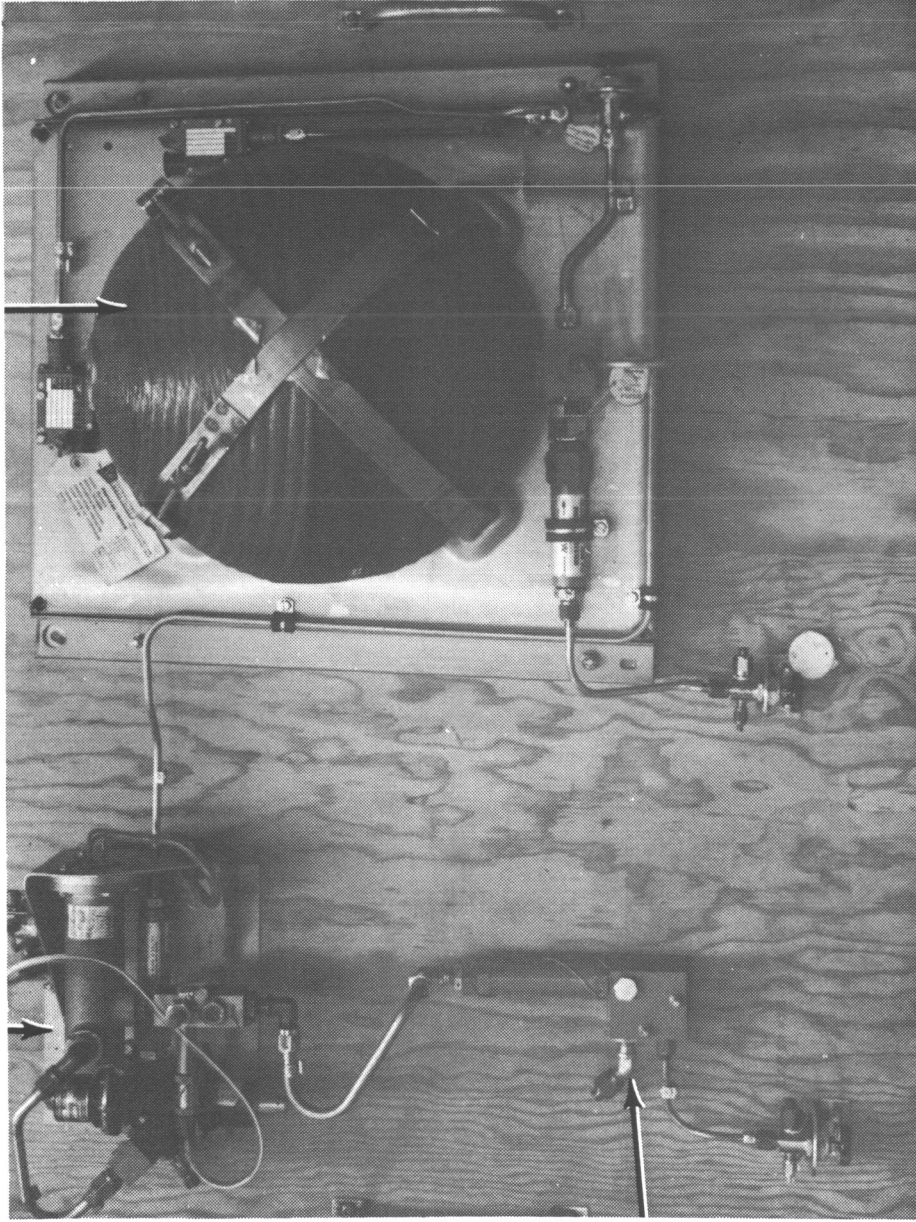
FIGURE 1. GAS BEARING SYSTEM - BREADBOARD MODEL

Figure 1 shows a breadboard model of the Block I Saturn configuration of the Gas Bearing Supply System. The Redstone and Jupiter, the Block I Saturn, and the Block II Saturn Gas Bearing Supply Regulation System configurations are shown in Figures 2, 3, and 4, respectively. The three systems are shown in Figure 5. The Block I Saturn configuration (Figure 3) constituted the first major design change by consolidating the two individual regulators and the solenoid and orifice by-pass into one integral unit.

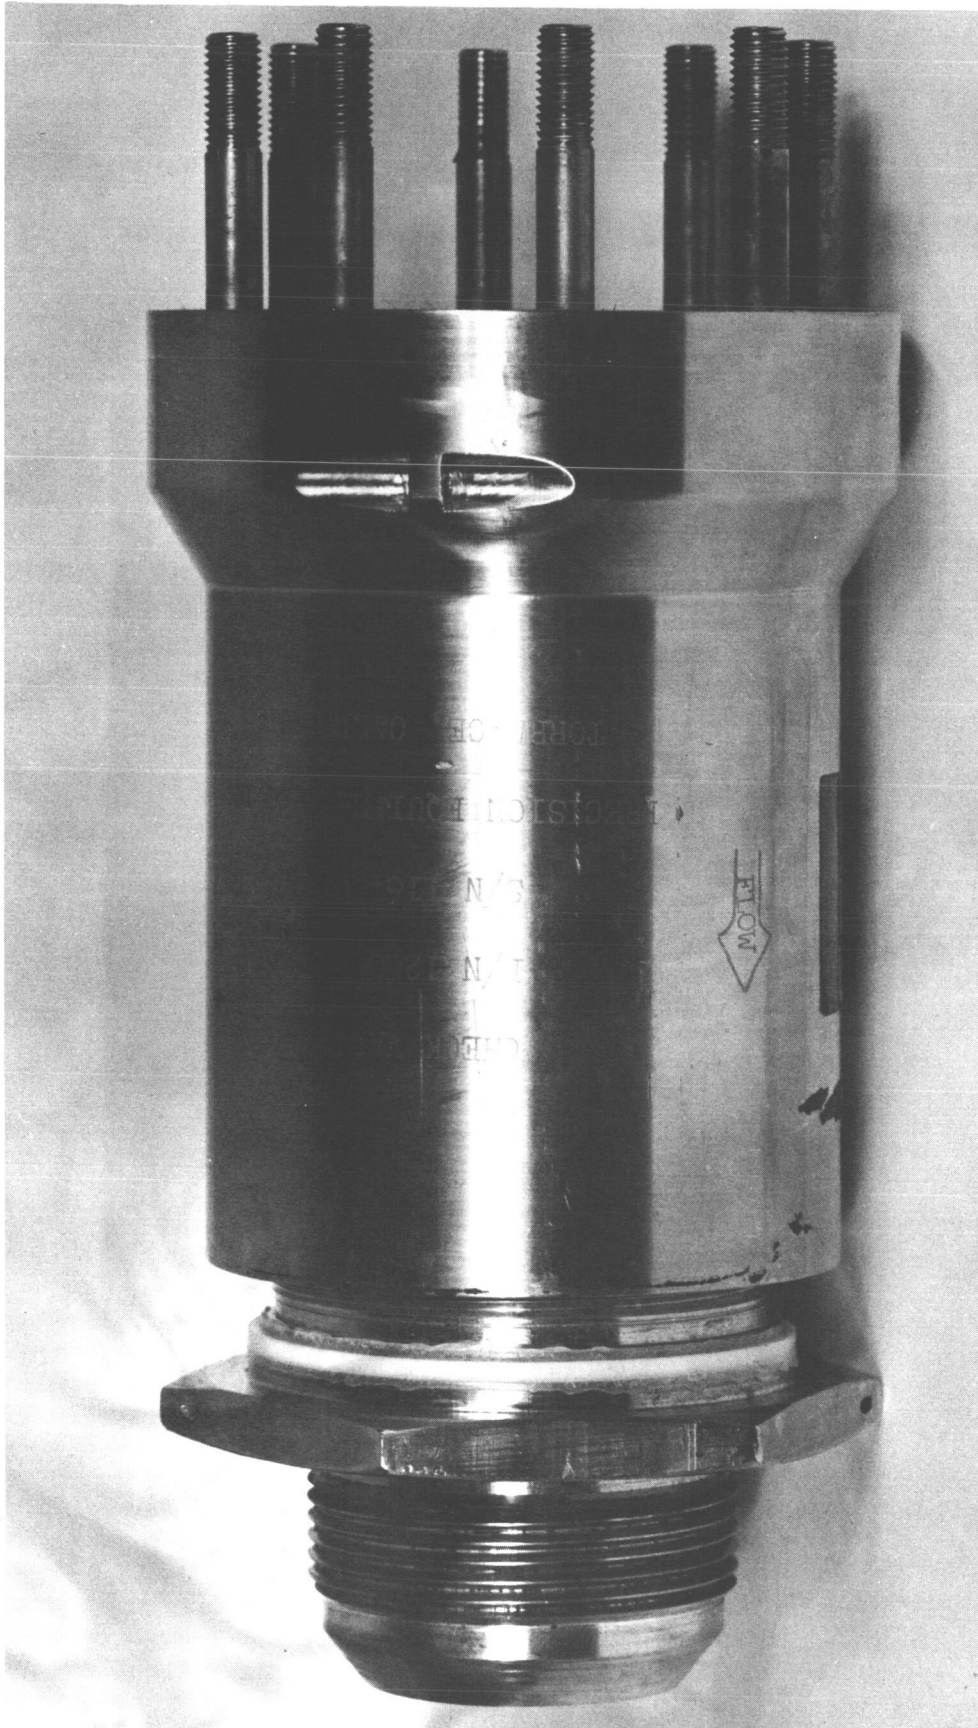
FIGURE 10. LOX HEAT EXCHANGER CHECK VALVE

A problem was also encountered with the LOX Heat Exchanger Check Valve. The LOX containers on the Saturn Vehicle are pressurized during flight by LOX which has passed through the rocket engine heat exchangers. Within this pressurizing system, check valves are located between the heat exchangers and the LOX containers. On the Block I Saturn vehicles no major problems with these check valves were encountered, but on the Block II Saturn the check valves were exposed to a higher temperature which caused external leaking during the static firing of SA-5. This increased heat caused the Teflon seal between the valve body halves to flow out of shape causing the valve to leak (Figure 10). This problem was corrected by changing the material of the housing seal from Teflon to copper (Figure 11).

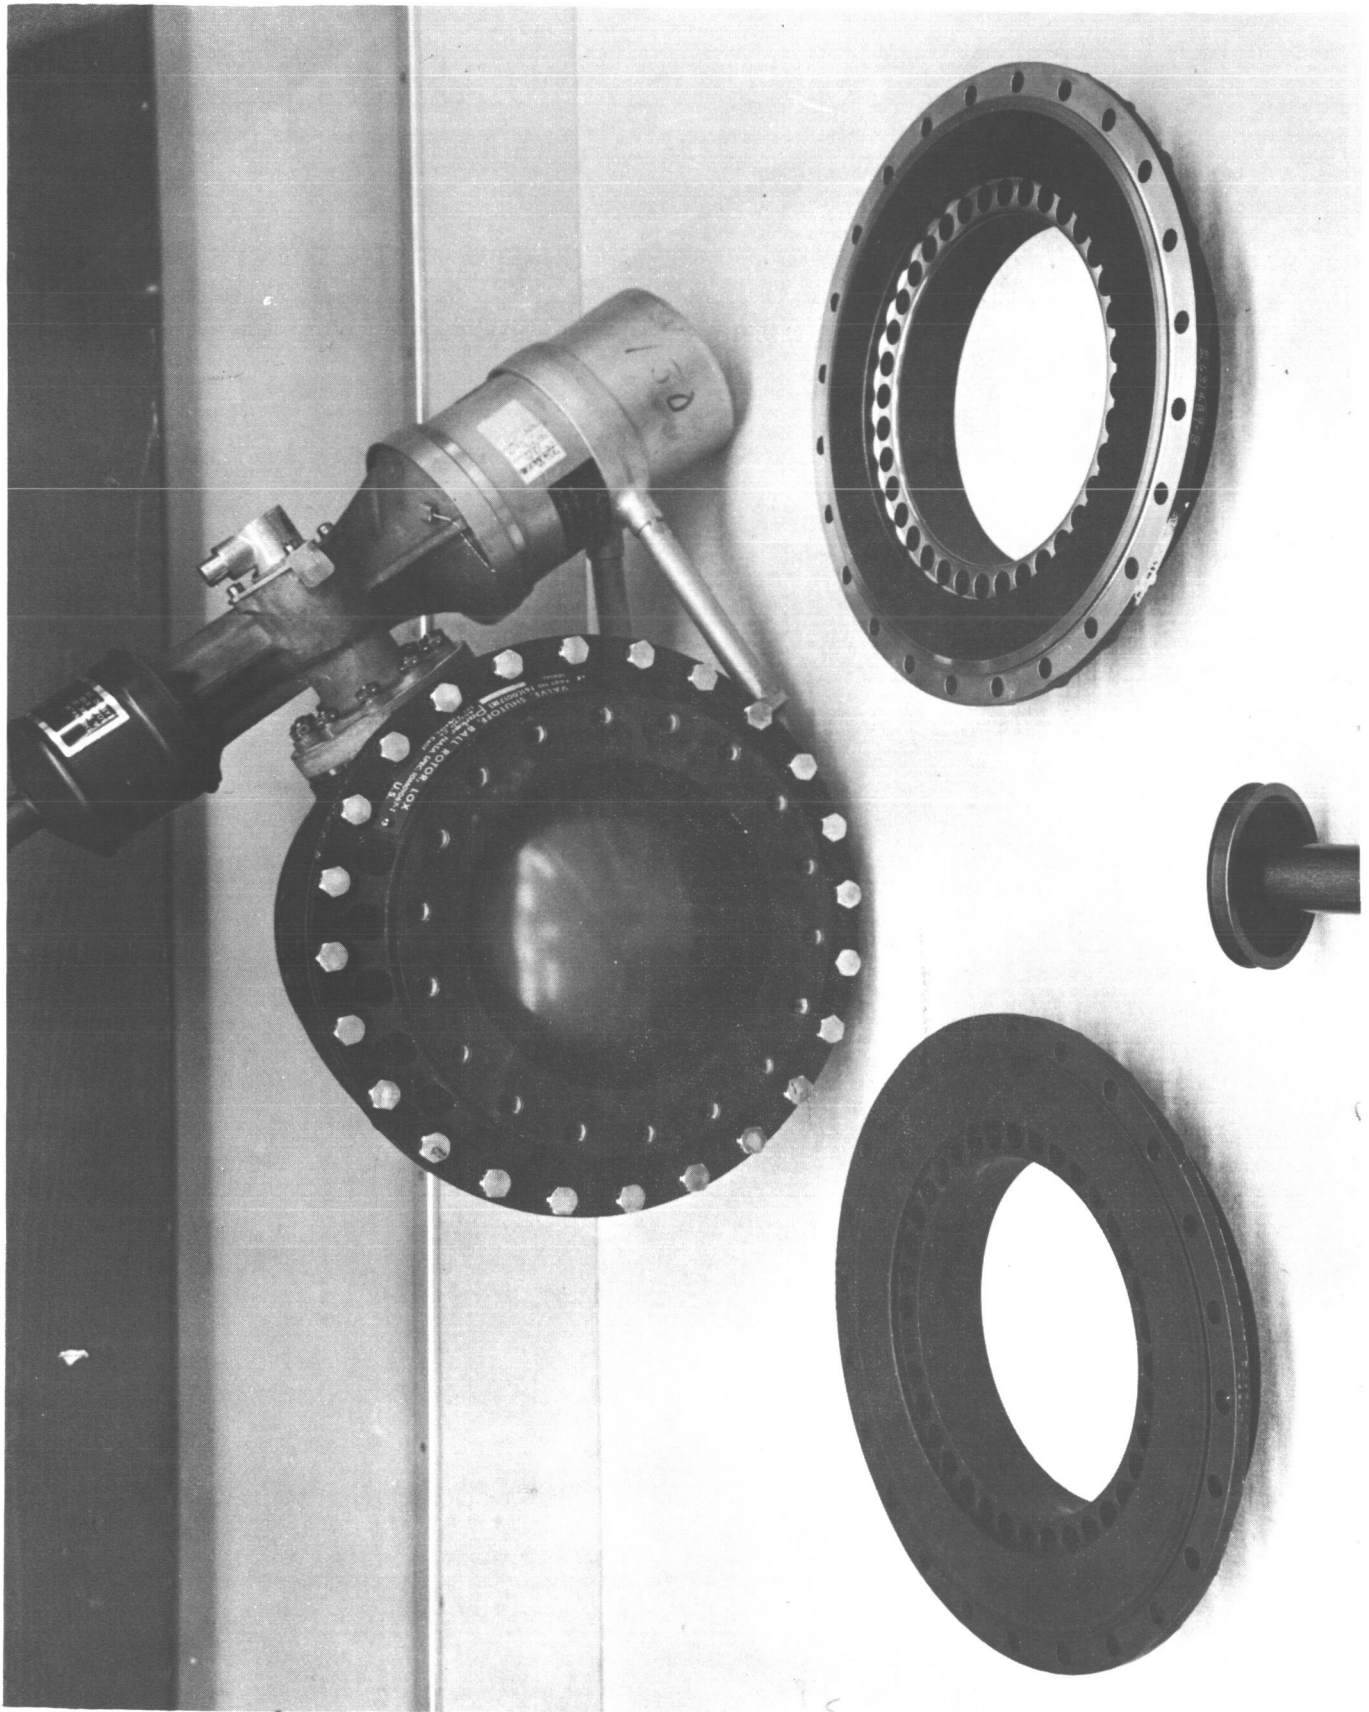
FIGURE 14. LOX CONTAINER FILL AND DRAIN VALVE

On the Block II Saturn Vehicles the same type valves are used as Pre-Valves in the engine feed lines and as container fill and drain valves in both the LOX and fuel systems. The only difference between the LOX and Fuel valves is a slight modification in the LOX valve so that it will operate in cold temperatures (Figure 14).

One problem with this valve occurred when the main seal leaked LOX during the static firing of SA-5. The cause of this failure was found to be a split in the outer portion of the main seal (Figure 15). The cause of the split was found to be the serrated design of the flange which secures the O.D. of the main seal. These male serrations would cut into the seal to prevent leakage. Because the main seal is made of Teflon, which has a tendency to flow under pressure, the male serrations cut sufficiently into the seal so that the pressure imposed on the valve during static tests caused the seal to split. The solution to this problem was to reverse the serrations. The male serrations were removed and female serrations machined into the flange (Figure 16).

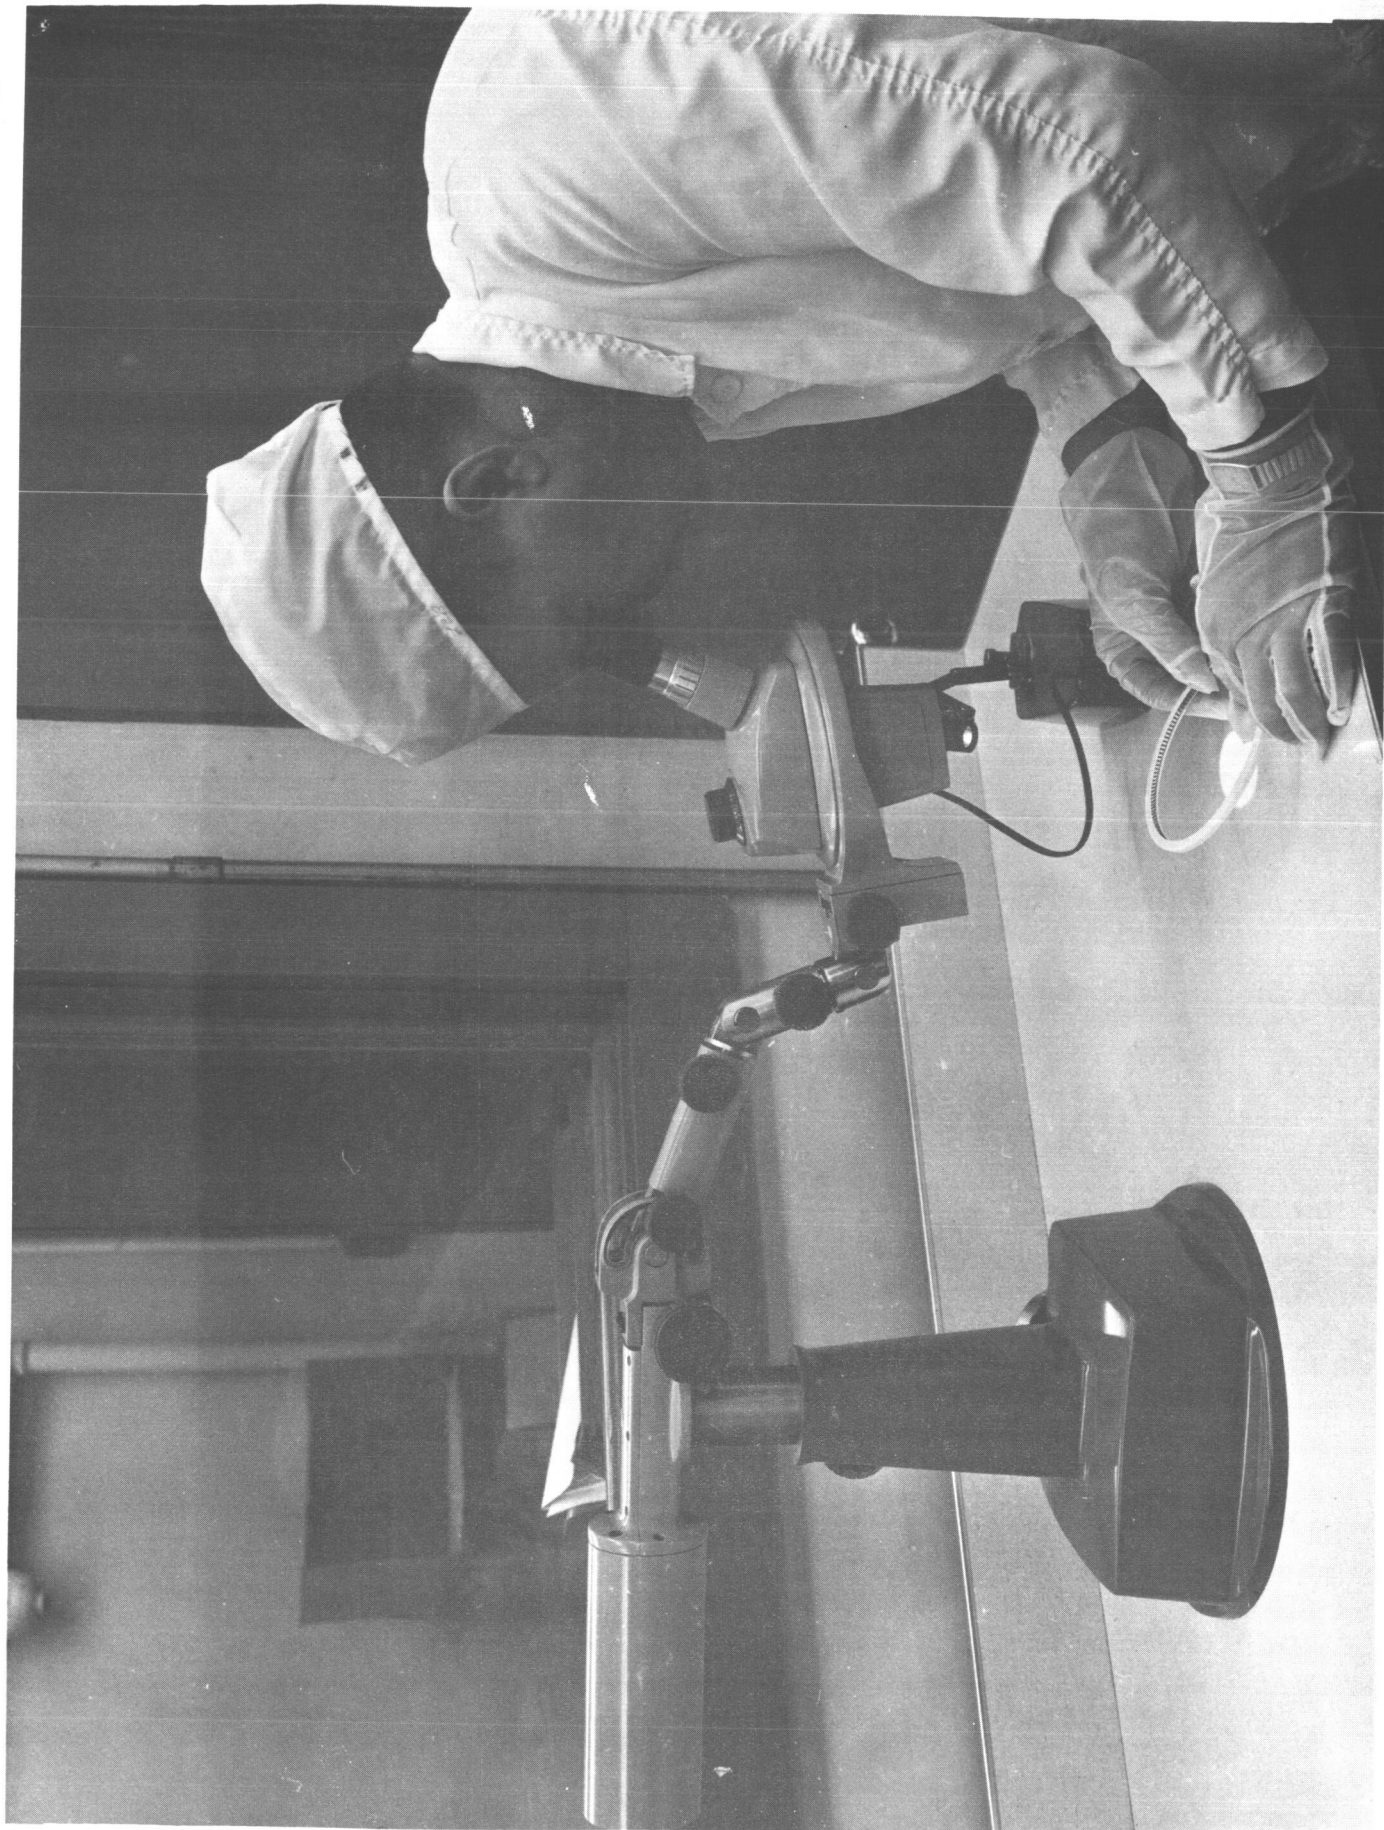
FIGURE 22. CHECKING A SEAL FOR DEFECTS PRIOR TO INSTALLATION IN A VALVE

Figure 22 shows one of the technicians checking a seal for defects prior to installation in a valve.
